### 3+2 error code diagnostic

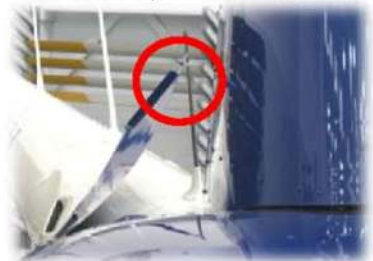
Cowl door open beside antenna

- Kannad ELTs are sensitive to VSWR : reflected wave from the antenna can perturb the self-test power measurement thus producing a 3+2 error code.
  - This is particularly true when a cowl door is open near the antenna or if any other metal part is close to the antenna, causing reflections
  - The length of the coaxial cable can also influence the reflected wave. Increasing the length of the coaxial cable by a few centimeters may solve the temporary fault.

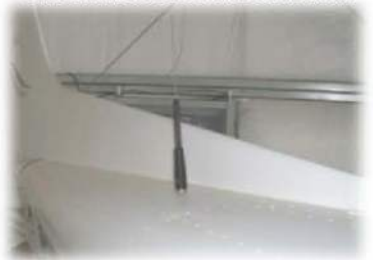
Antenna close to the dorsal fin
